Newsflash 1

Section: sectie sewage treatment No 1

Experiments on the prevention and removal of scale using “*Scalewatcher*TM”

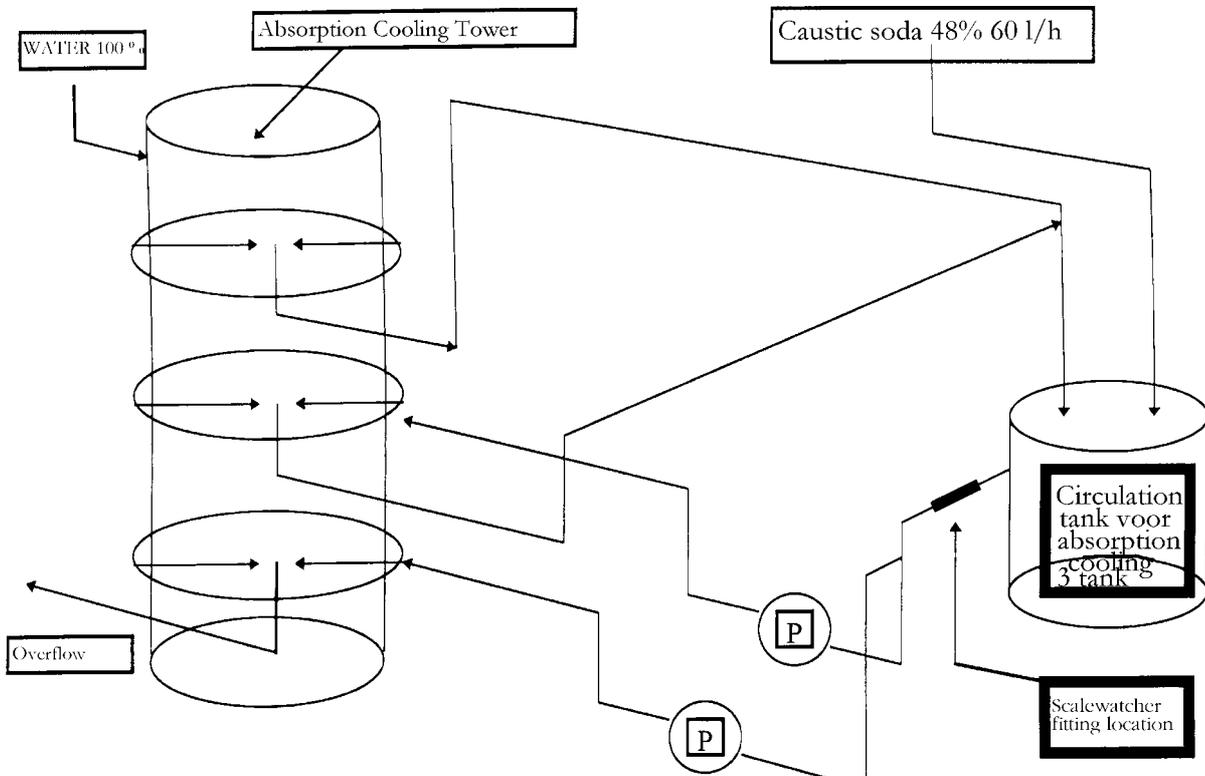
The *Scalewatcher*TM was fitted to the absorption-cooling tower of the incinerator and the absorption cooling tower circulation piping, and its effectiveness measured. The circulation flow of the absorption-cooling tower is shown in fig 1, and the *Scalewatcher*TM installation in photo 2.

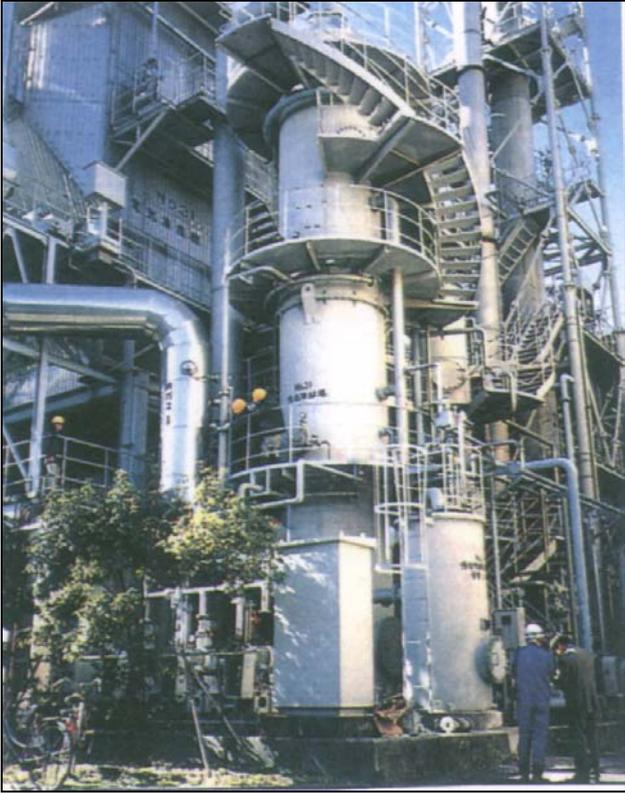
nr 1

- Test location : Sewage treatment works, city “A”. (Incinerator/absorption cooling tower) photo NR. 1
- Test term : 20th December 1995 ~ 17th April 1996
- Test operators : Nippon Health Industries Co. Ltd. Chemical Services Commercial

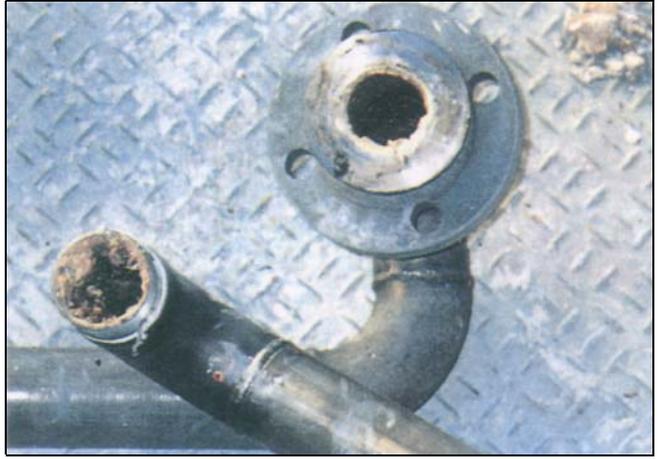
nr. 4

Approximately 3 months after chemical washing and cleaning of the pipes, around 10 mm of scale ranging from white to light brown in colour had formed in the 100 Ø piping.

In the 50 Ø piping, spray nozzle and vicinity, the piping was completely blocked (photos 3 and 4).

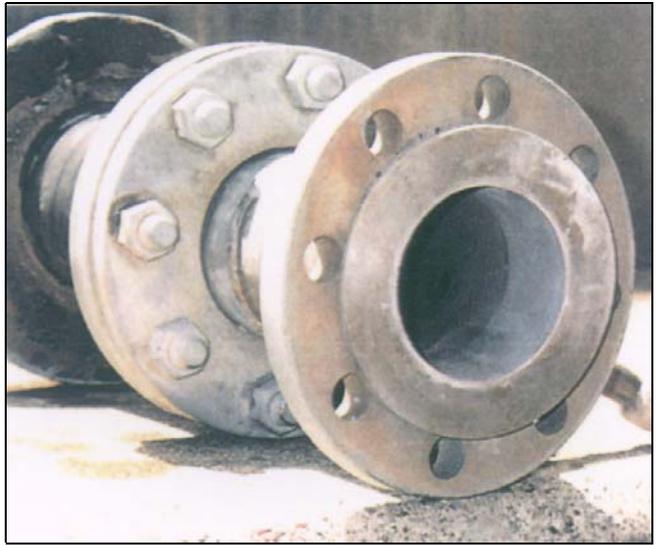
nr. 5

4 Circulation pump outlet pressure/ electric current value (photos 5 and 6)

The outlet pressure and electric current values showed no substantial change, both two months and four months after fitting **Scalewatcher**[™] (see Table 3).
